NATIONAL TRANSPORTATION SAFETY BOARD

Systems Group Chairman's Factual Report

DCA-06-MA-022

Operator: United Parcel Service Company
Location: Philadelphia International Airport (PHL), Philadelphia, Pennsylvania
Date: February 7, 2006
Time: Approximately 1159 local time
Airplane: Douglas (Boeing) DC-8-71F, N748UP

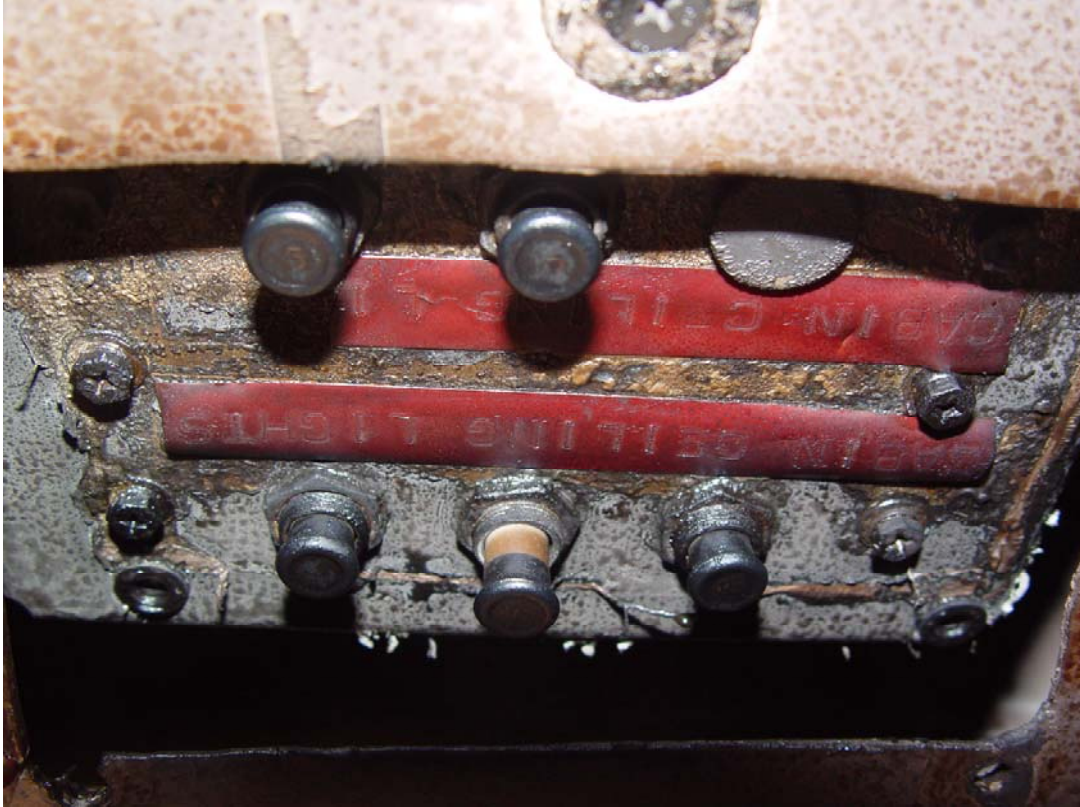
Figure 2
Circuit Breaker Panel Located in the Flight Deck Entry Area Ceiling

The circuit breakers in the entryway were examined, and all of the circuit breakers were found to be “in” (closed) with the exception of the middle circuit breaker in the row of three breakers. Each row of circuit breakers in this panel was found labeled (using a label maker) as “Cabin Ceiling Lights”. (See figure 2)
